Intel[®] Pentium[®] 4 Processor Specification Update

Release Date: February 2002

Order Number: 249199-019

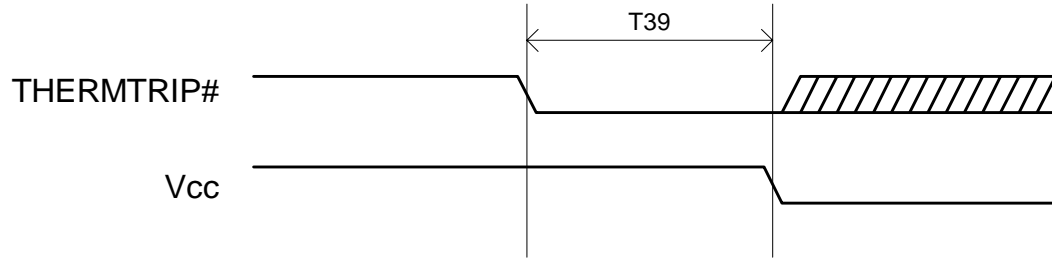
The following figure will be added as Figure (new). THERMTRIP# Power Down Sequence

Assertion of THERMTRIP# (Thermal Trip) indicates the processor junction temperature has reached a level beyond which permanent silicon damage may occur. Measurement of the temperature is accomplished through an internal thermal sensor which is configured to trip at approximately 135°C. Upon assertion of THERMTRIP#, the processor will shut off its internal clocks (thus halting program execution) in an attempt to reduce the processor junction temperature. To protect the processor, its core voltage (V_{CC}) must be removed following the assertion of THERMTRIP#. See Figure (new) and Table 13 for the appropriate power down sequence and timing requirements. Once activated, THERMTRIP# remains latched until RESET# is asserted. While the assertion of the RESET# signal will de-assert THERMTRIP# , if the processor's junction temperature remains at or above the trip level, THERMTRIP# will again be asserted after RESET# is de-asserted.

<u>T# Parameter</u>	<u>Min</u>	<u>Max</u>	<u>Unit</u>	<u>Figure</u>	<u>Notes</u>
T39: THERMTRIP# to removal of power	N/A	500	ms	(new)

$T39 < 0.5$ seconds

Note: THERMTRIP# is undefined when RESET# is active
